## FINAL REPORT

### ELEVATED TEMPERATURE STRESS CORROSION OF HIGH STRENGTH SHEET MATERIALS IN THE PRESENCE OF STRESS CONCENTRATORS

Contract NASr-50

**MECHANISM OF HOT SALT STRESS  
CORROSION CRACKING OF TITANIUM BASE ALLOYS**

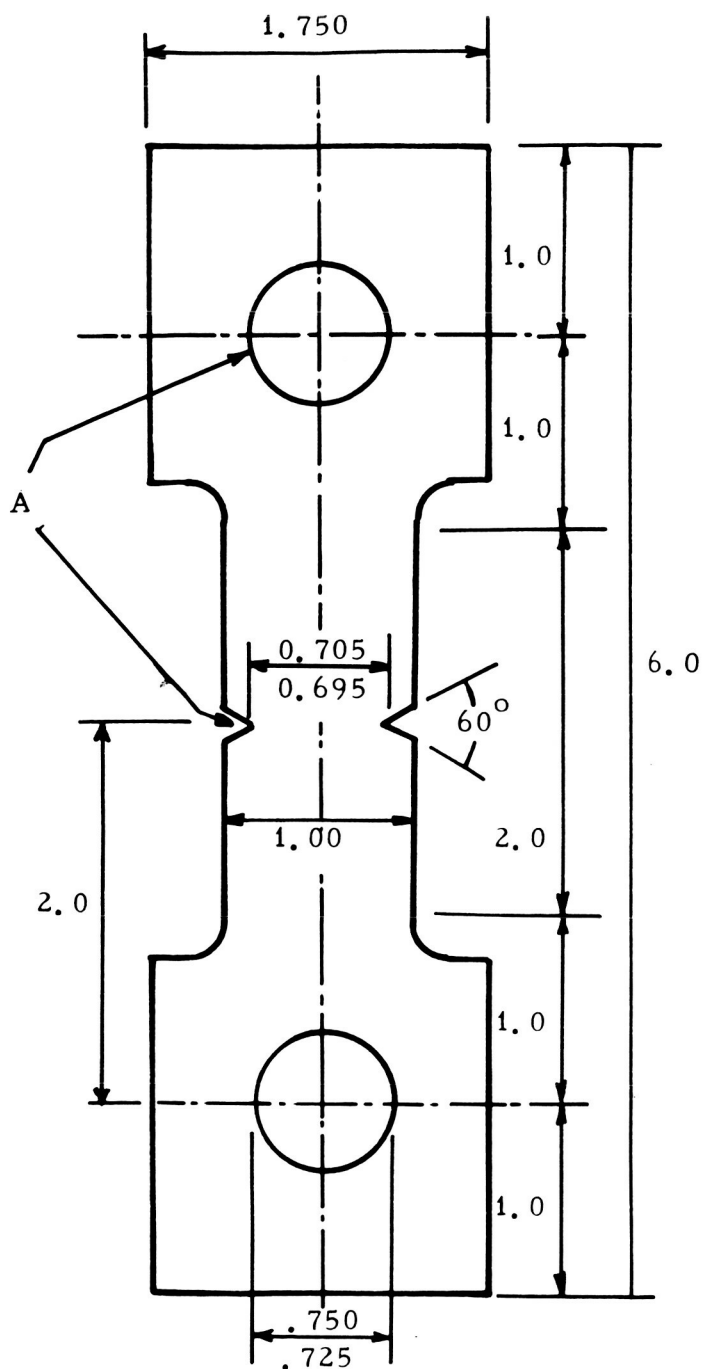
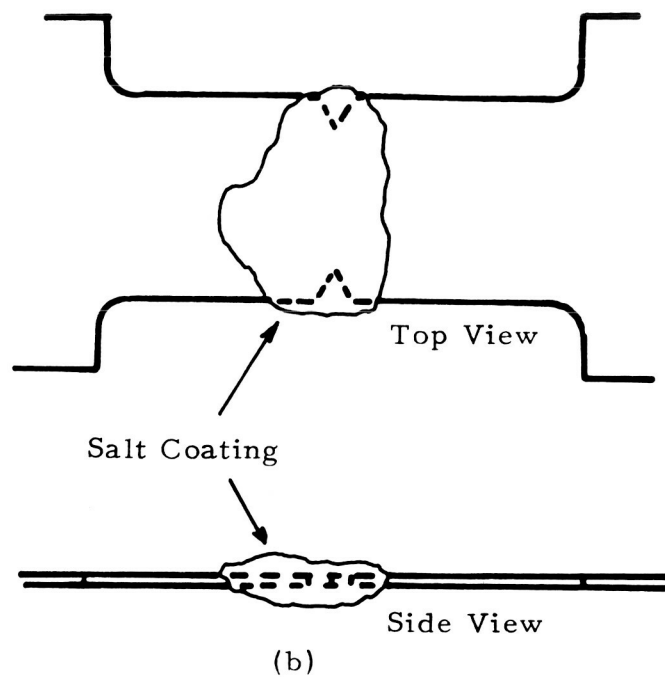
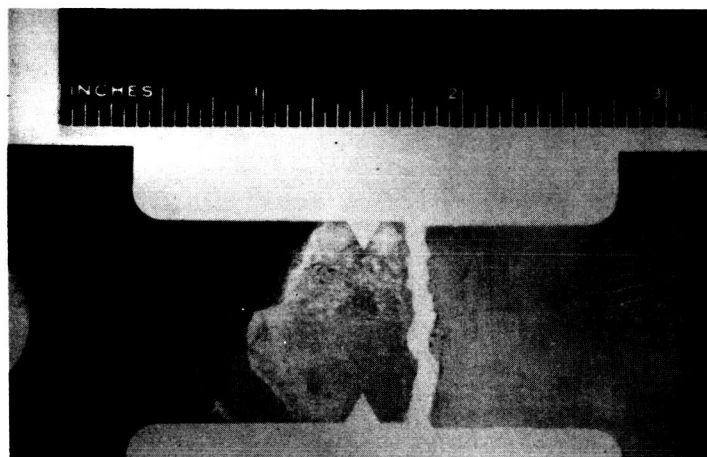
A - Surfaces true to centerline within  
0.001 inch. Notch root radius  
less than 0.001 inch.

Fig. 1 CRACKING IN A HEAVILY COATED EDGE NOTCH SPECIMEN

(a) SPECIMEN DIMENSIONS

(b) METHOD OF SALT COATING

(c) APPEARANCE OF FRACTURED SPECIMEN (Ti-8Al-1Mo-1V)

One unique aspect of the stress corrosion cracking of these alloys is its apparent insensitivity to initial stress concentrators. When sharply notched specimens, with the dimensions shown in Fig. 1a, were heavily salt coated in the vicinity of the notch, as shown schematically in Fig. 1b, and exposed at 650°F to a nominal stress of 25,000 psi (calculated on the basis of the notch section area), they cracked at the edge of the salt layer, Fig. 1c, rather than across the notch plane where the stress is far higher due to both the reduced cross-section and the stress concentration (9). Since the specimens crack at the location of lower stress, it might be assumed that cracking is independent of applied stress. This is shown not to be the case, however, by the smooth tensile specimen exposure data in Fig. 2. Hence it must be assumed that stress corrosion cracks can form only at the edge of the salt layer, and the load carrying capacity at this location is reduced far more than is the strength reduction produced by the mechanical notch.

As shown in Table II, the control specimen did not fracture within the period of the subsequent room temperature test. The coated specimen given the shortest exposure developed a small crack while the remainder fractured completely in very short times. In all cases, cracking occurred across the notch plane, Fig. 10, unlike the condition shown in Fig. 1, where cracking was restricted to the edge of the heavy

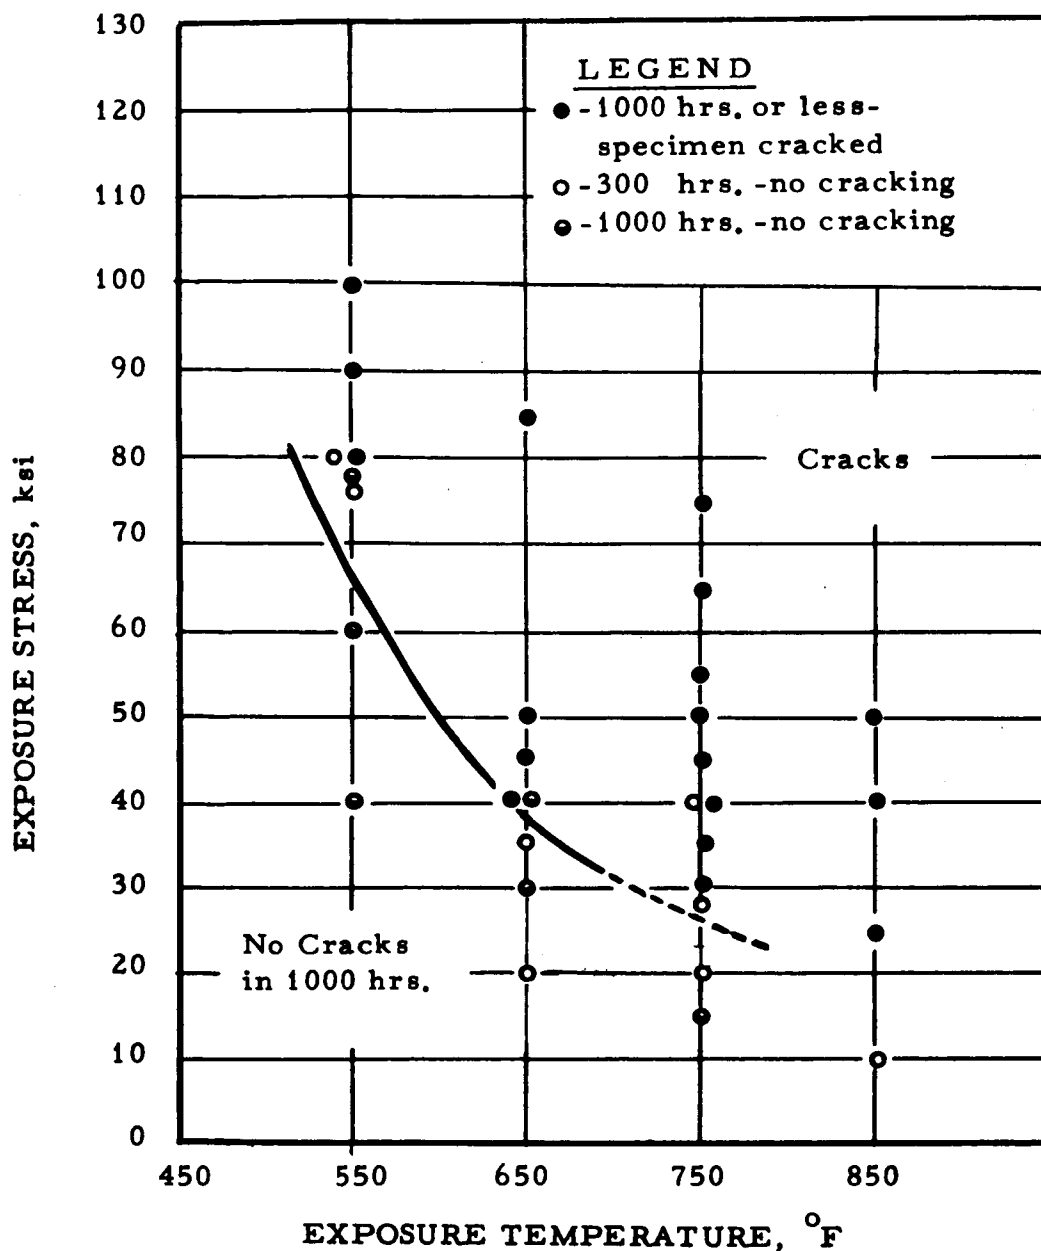
Fig. 2 EFFECT OF EXPOSURE STRESS AND TEMPERATURE ON FRACTURE OF ANNEALED Ti-6Al-4V ALLOY IN THE PRESENCE OF NaCl

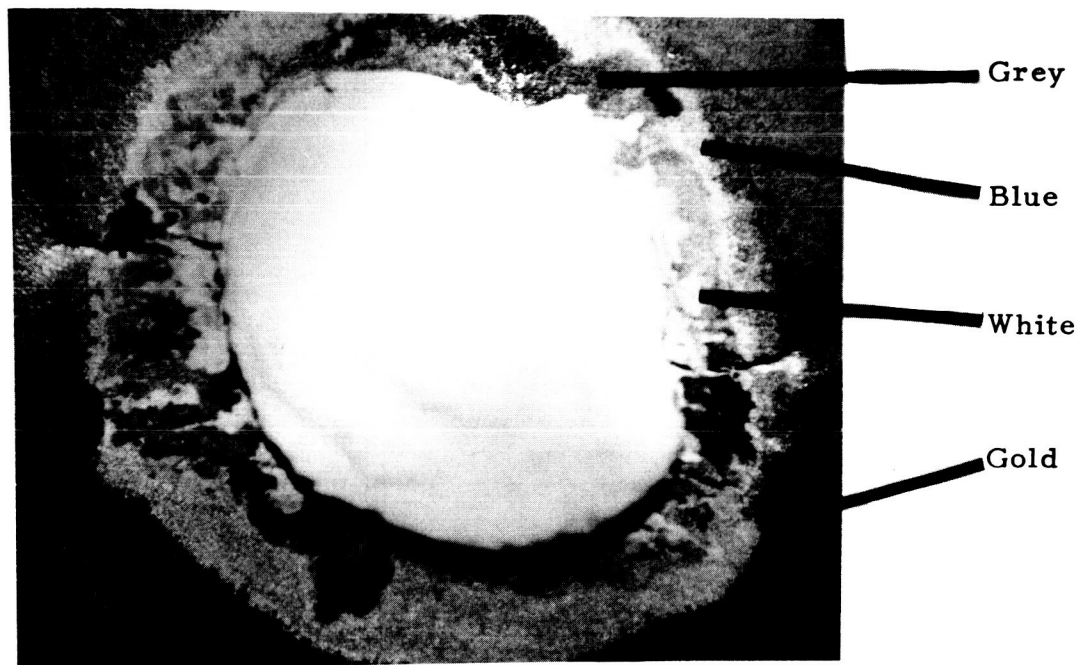
Fig. 3 CRACKING IN THE VICINITY OF THE SOLID BEAD (Ti-8Al-1Mo-1V, EXPOSED 25 HOURS AT 650°F and 70,000 psi. SPECIMEN ETCHED BEFORE APPLYING SEA SALT SLURRY.) (25x)

Kirchner and Ripling showed this strength reduction to be associated with a gray corrosion product that formed at the periphery of heavy salt layers. Cracks always initiated near this location, Fig. 3. The fact that cracking is restricted to this single site suggests that the fracture is associated with an electro-chemical mechanism in which the metal near the salt-metal-air interface is always one electrode of the cell. Determining whether the periphery is the anode or cathode of the cell can be done by examining the metal after it has been in contact with a drop of the corroding agent. At the anode, metal is dissolved, i. e.,

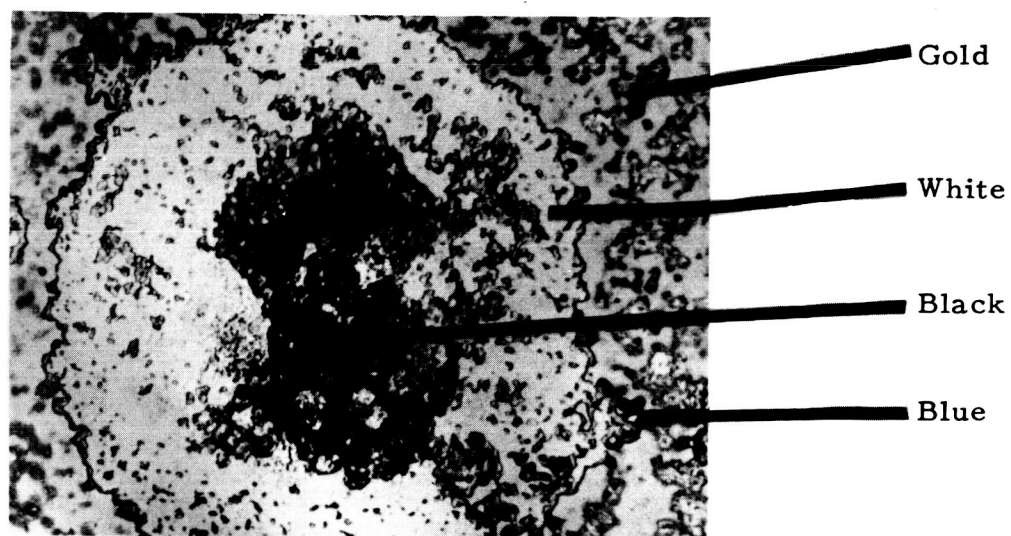
Fig. 4 APPEARANCE OF CORROSION PIT IN UNSTRESSED Ti-8Al-1Mo-1V SPECIMEN AFTER 5 HOURS AT 800°F (260x)

Hence, small beads of a slurry of natural sea salt were placed on metallographically polished surfaces of Ti-8Al-1Mo-1V alloy and heated to 800°F for five hours in the absence of stress. After the high temperature exposure, the salt and corrosion products were carefully washed off, and the metal in the vicinity of the original salt bead had the appearance shown in Fig. 4. Under the center section of the bead, where air was excluded, the metal was dissolved indicating an anodic reaction. At the periphery of the salt bead the oxide appears to have been removed implying a cathodic reaction. The appearance of the pit in relation to the original salt bead is more clearly seen in Fig. 5. Note that in short exposure times, metal is dissolved only under the center of the bead where oxygen is least available. This appearance would suggest that titanium alloys, in the presence of hot solid salt, corrode because of an oxygen differential cell, much as is the case for a salt water drop on steel (2). The metal under the thickest part of the salt bead, i. e., its center, is deficient in oxygen as compared with that near the periphery.

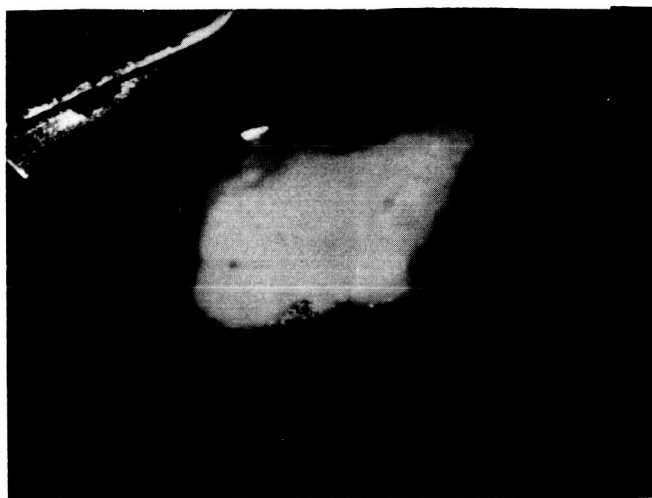
Fig. 5 SURFACE ATTACK OF SEA SALT ON UNSTRESSED Ti-8Al-1Mo-1V SPECIMEN

- (a) APPEARANCE OF SALT BEAD AND CORROSION PRODUCTS AFTER BEING EXPOSED AT 800°F FOR 5 HOURS (25x)
- (b) SURFACE ATTACK AFTER REMOVAL OF SALT AND CORROSION PRODUCTS (25x)
- (c) ENLARGED VIEW OF ATTACKED AREA (50x).

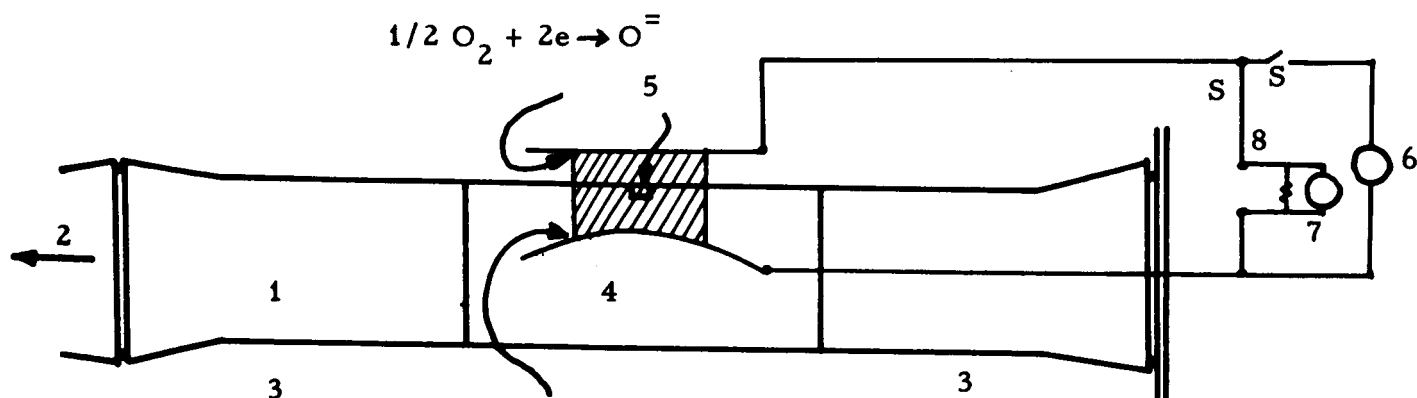
**Fig. 6** SCHEMATIC DIAGRAM OF CONTROLLED ATMOSPHERE CORROSION CELL.

1. Vacuum or argon chamber
2. To vacuum or argon
3. Glass ends of 4 inch diameter tube
4. Glazed alumina tube sealed to glass  
(glazed to prevent porosity)
5. Unglazed area on tube permeated with salt
6. Vacuum tube voltmeter
7. L and N mv. recorder
8. Precision resistor

piece of titanium, exposed to the air, was in contact with the first one through a salt bridge and also connected to it electrically by a nickel wire. A schematic diagram of the cell is shown in Fig. 6, and the details of its construction have been previously described (9). When the system was heated to the vicinity of 650 to 800<sup>o</sup>F, an emf varying from 1.0 to 0.1 volts was measured and the direction of current flow showed that the inside oxygen deficient specimen was the anode and the outside the cathode.

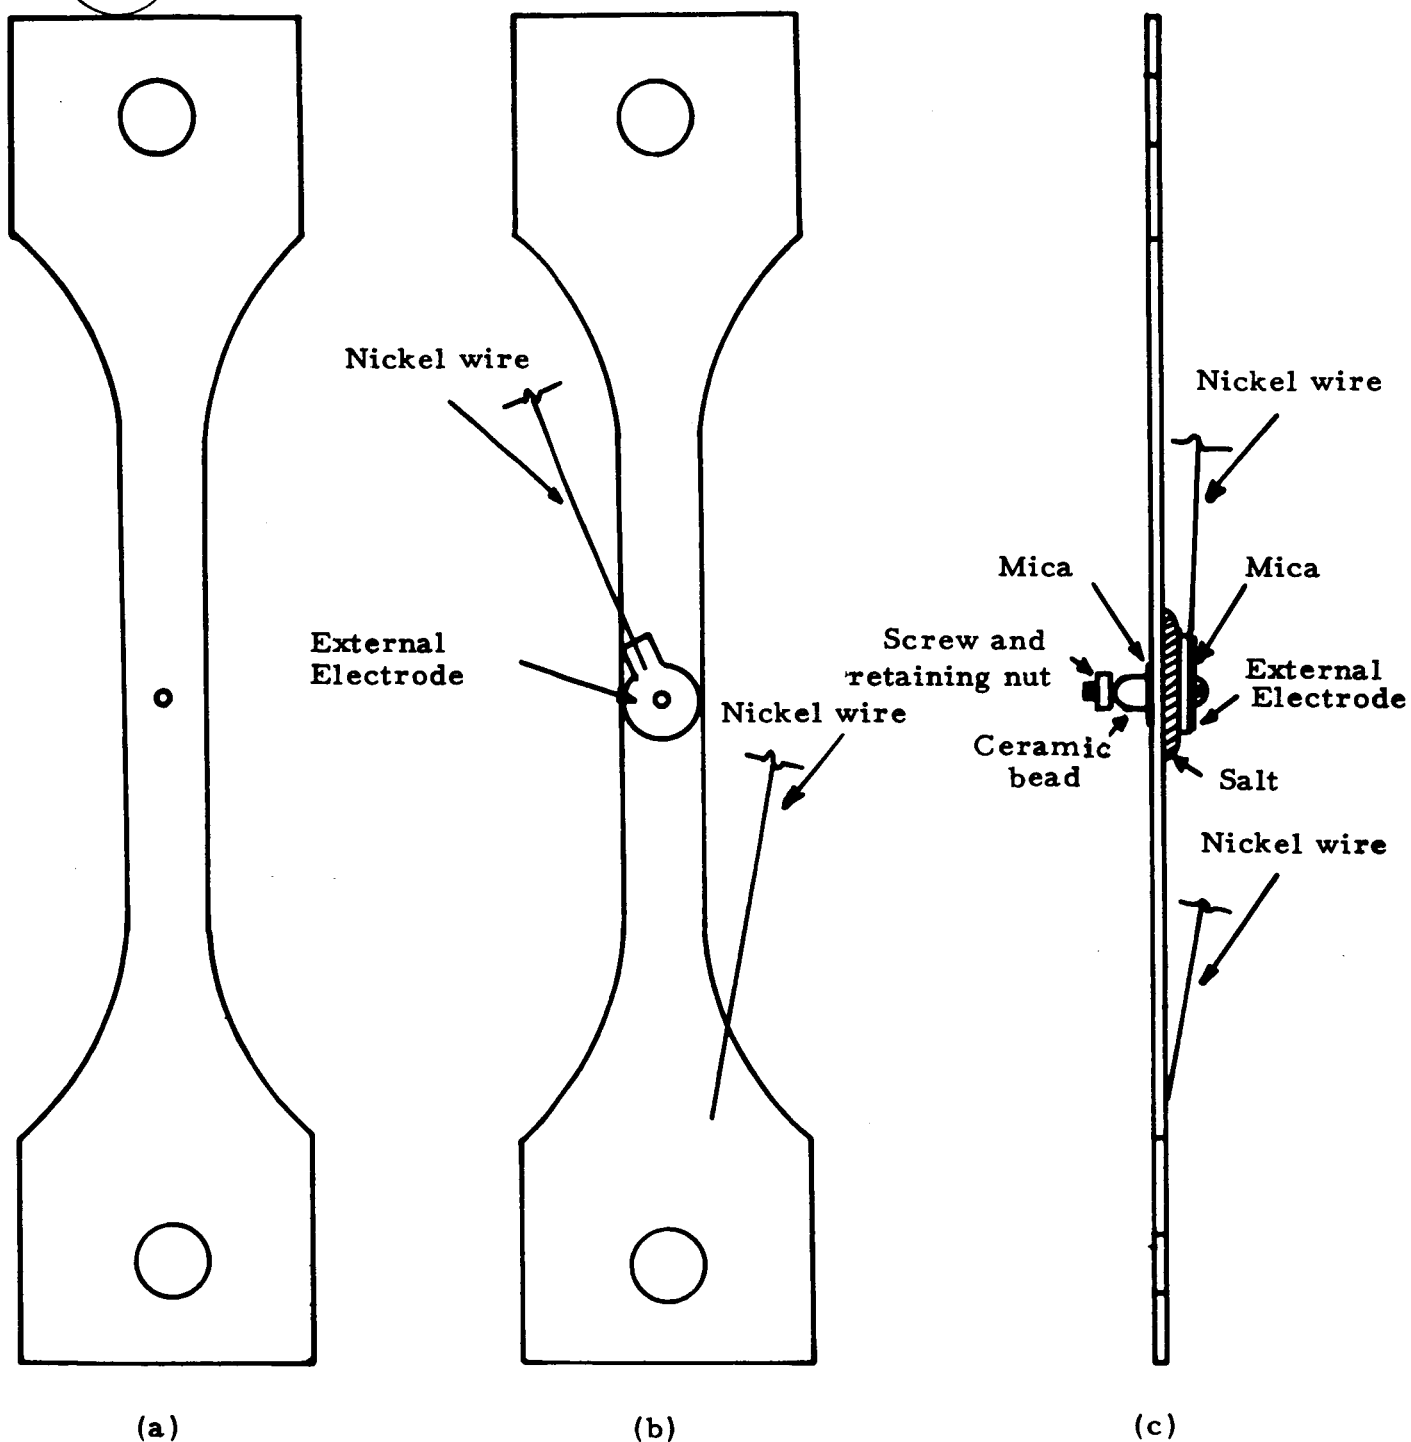
**Fig. 7** DIAGRAM OF THE IMPRESSED ANODE AND CATHODE SPECIMENS.

- (a) TENSILE SPECIMEN WITH HOLE.
- (b) TENSILE SPECIMEN WITH EXTERNAL ELECTRODE AND WIRES ATTACHED.
- (c) SIDE VIEW OF THE TENSILE SPECIMEN SHOWING THE DETAILED CONSTRUCTION OF THE TITANIUM-SALT-TITANIUM CELL.

Since cracking appears to be identified with the cathodic region, it should be possible to prevent failures by making the stressed member the anode in a titanium-salt-titanium cell. In order to do this, a small hole was drilled into the reduced section of tensile specimens, Fig. 7a. After drilling, the specimen was cleaned in acetone and then in Alconox. One side of the specimen was then coated with a thick salt slurry, and a small metal tab of the same alloy (Ti-8Al-1Mo-1V), Fig. 7b, placed over the salt, and the assembly held together with a single steel screw and nut, Fig. 7c. The fastener was insulated from the titanium surfaces by a small sheet of mica under the head of the screw and a sheet of mica and ceramic bead under the nut. The screw was prevented from touching the sides of the hole by making the hole considerably larger than the screw diameter.

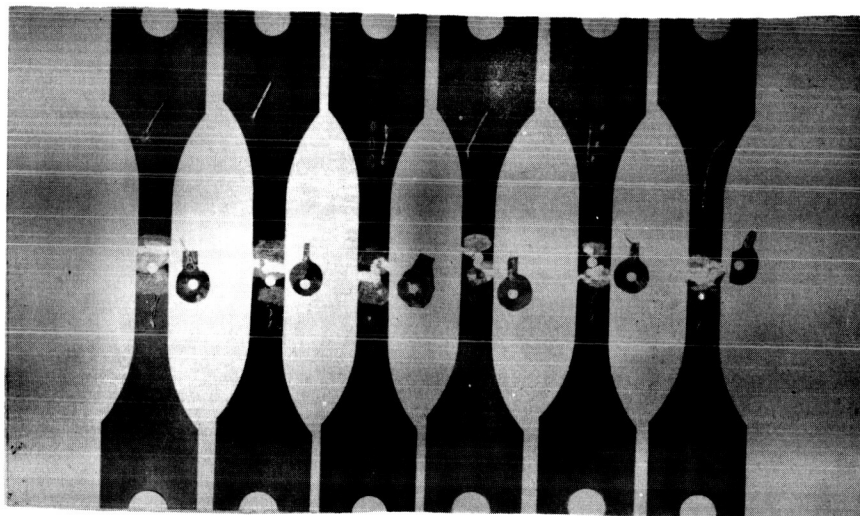
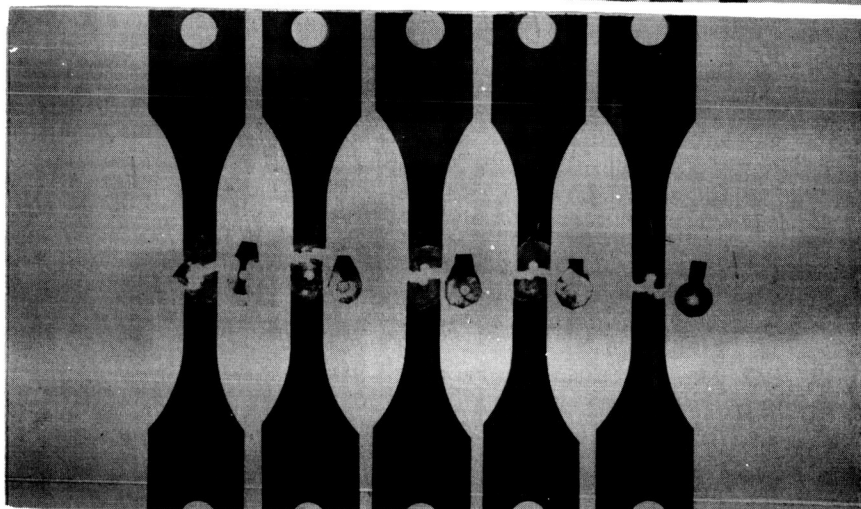
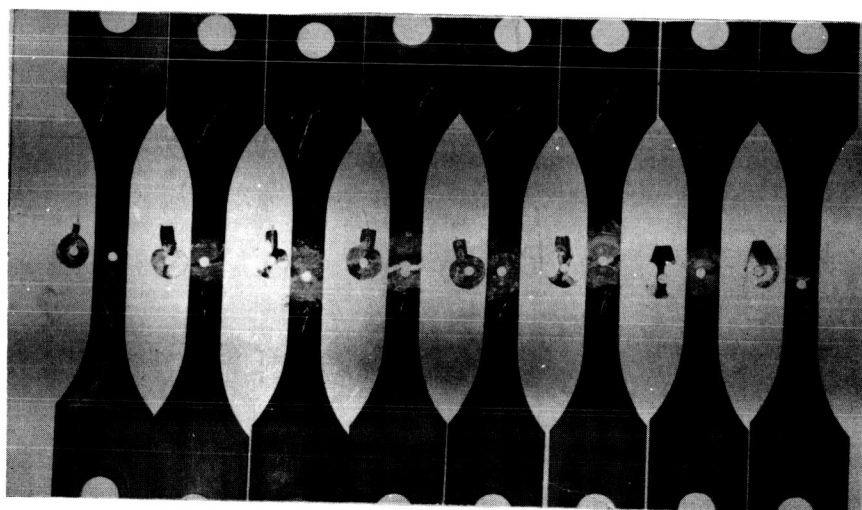
Fig. 8 APPEARANCE OF IMPRESSED EMF SPECIMENS AFTER TESTING:

- (a) IMPRESSED CATHODE SPECIMENS AFTER EXPOSURE TO 650°F AND 50,000 psi UNTIL FAILURE
- (b) CONTROL SPECIMENS AFTER EXPOSURE TO 650°F AND 50,000 psi UNTIL FAILURE
- (c) IMPRESSED ANODE SPECIMENS AFTER EXPOSURE TO 650°F AND 50,000 psi UNTIL TEST WAS STOPPED

In the first group, consisting of six tests, the specimen was made the cathode of a 25 volt cell, Fig. 8a, and as shown in Table I, fractures occurred in times between 26 and 180 hours. The second group of five specimens was tested to serve as controls, Fig. 8b, in which no voltage was applied, and these failed between 2 and 155 hours. Note that most of these control specimens did not fracture at the edge of the salt layer. This resulted because air could travel through the

hole to the salt coated side of the specimen since they were not coated on the back side. Hence, cathodes would be expected to form both near the edge of the salt layer and the periphery of the hole. In a third series, eight stressed specimens were made the anode, Fig. 8c, and although one failed in fourteen hours, the remainder of the specimens did not fail within the total test period which varied from 225 to 864 hours. Since currents were not measured during the test, it is probable that poor contact was made between the specimen, salt and electrode in the single test in which premature fracture occurred. In the final test series, six specimens were again made the anode but in this case, an impressed emf of 2.0 volts was used. As shown in Table I, none of these six failed within the 300 hour test period.

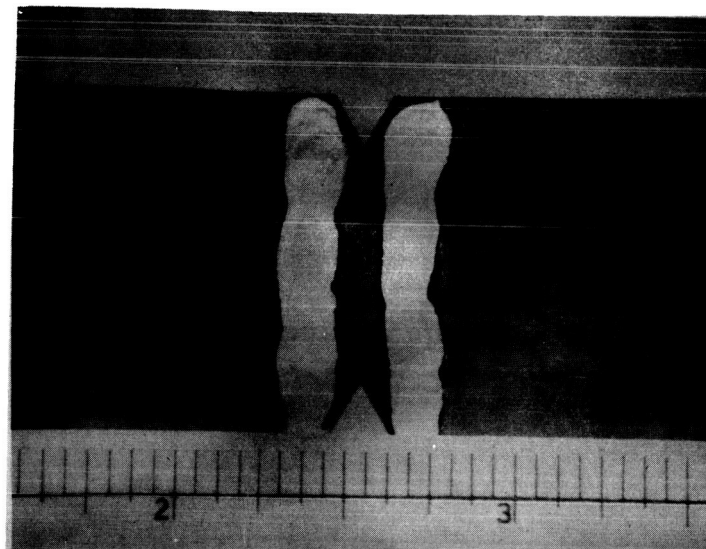
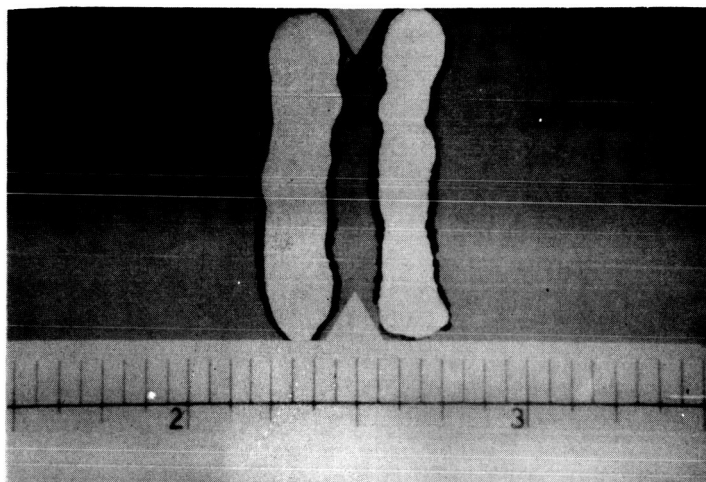
Fig. 9 LOCATION OF SALT BEADS AND SURFACE APPEARANCE OF Ti-8Al-1Mo-1V NOTCH SPECIMEN AFTER EXPOSURE AT 800°F FOR 24 HOURS WITH NO LOAD. Note that corrosion products (dark stain at periphery of salt bead) did not extend to notch plane. (1.75 X)

To determine whether or not such cracking could occur, specimens were coated with a narrow salt bead on either side of the notch, on both sides of the specimen, as shown in Fig. 9. These, as well as a single uncoated specimen, used as a control, were then placed into a tube furnace and heated to 800<sup>o</sup>F (one to two hours was required to reach temperature) held 7, 8 or 24 hours after which they were air cooled to room temperature. The salt and corrosion products were then washed off with distilled water. (The specimens exposed for 24 hours were also metallographically polished in the vicinity of the notch plane to be certain that even water insoluble corrosion products were removed.) The cleaned specimens were then subjected to 100,000 psi (net section stress) at room temperature.

In spite of the fact that these specimens were thoroughly cleaned after high temperature salt exposure, corrosion times and temperatures were selected such that none of the surface corrosion product would diffuse to the notch plane. (Note the limits of the dark corrosion product at the periphery of the salt beads in Fig. 9.)

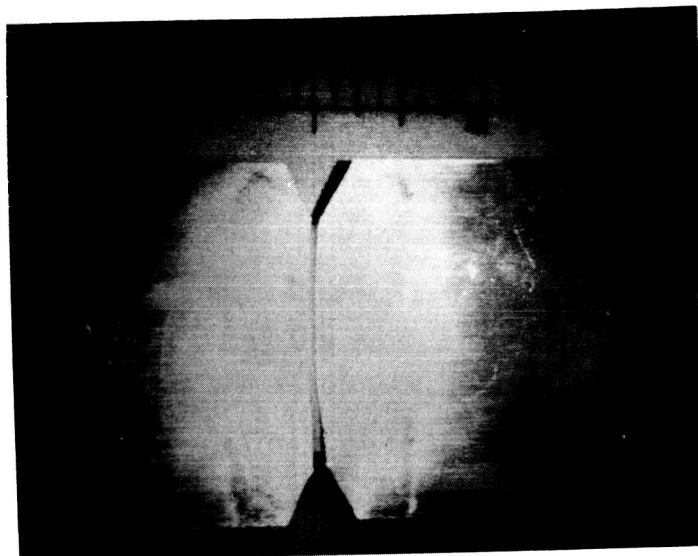
Fig. 10 LOCATION OF FAILURE AND SURFACE APPEARANCE  
OF Ti-8Al-1Mo-1V NOTCH SPECIMEN (1.75 X) TREATED  
AS FOLLOWS:

- (1) Salt coated as shown in Fig. 9
- (2) Exposed 24 hours at 800°F - no load
- (3) Air cooled and washed
- (4) Metallographically polished in vicinity of notch
- (5) Exposed to 100,000 psi at room temperature -  
cracked in <1 minute.

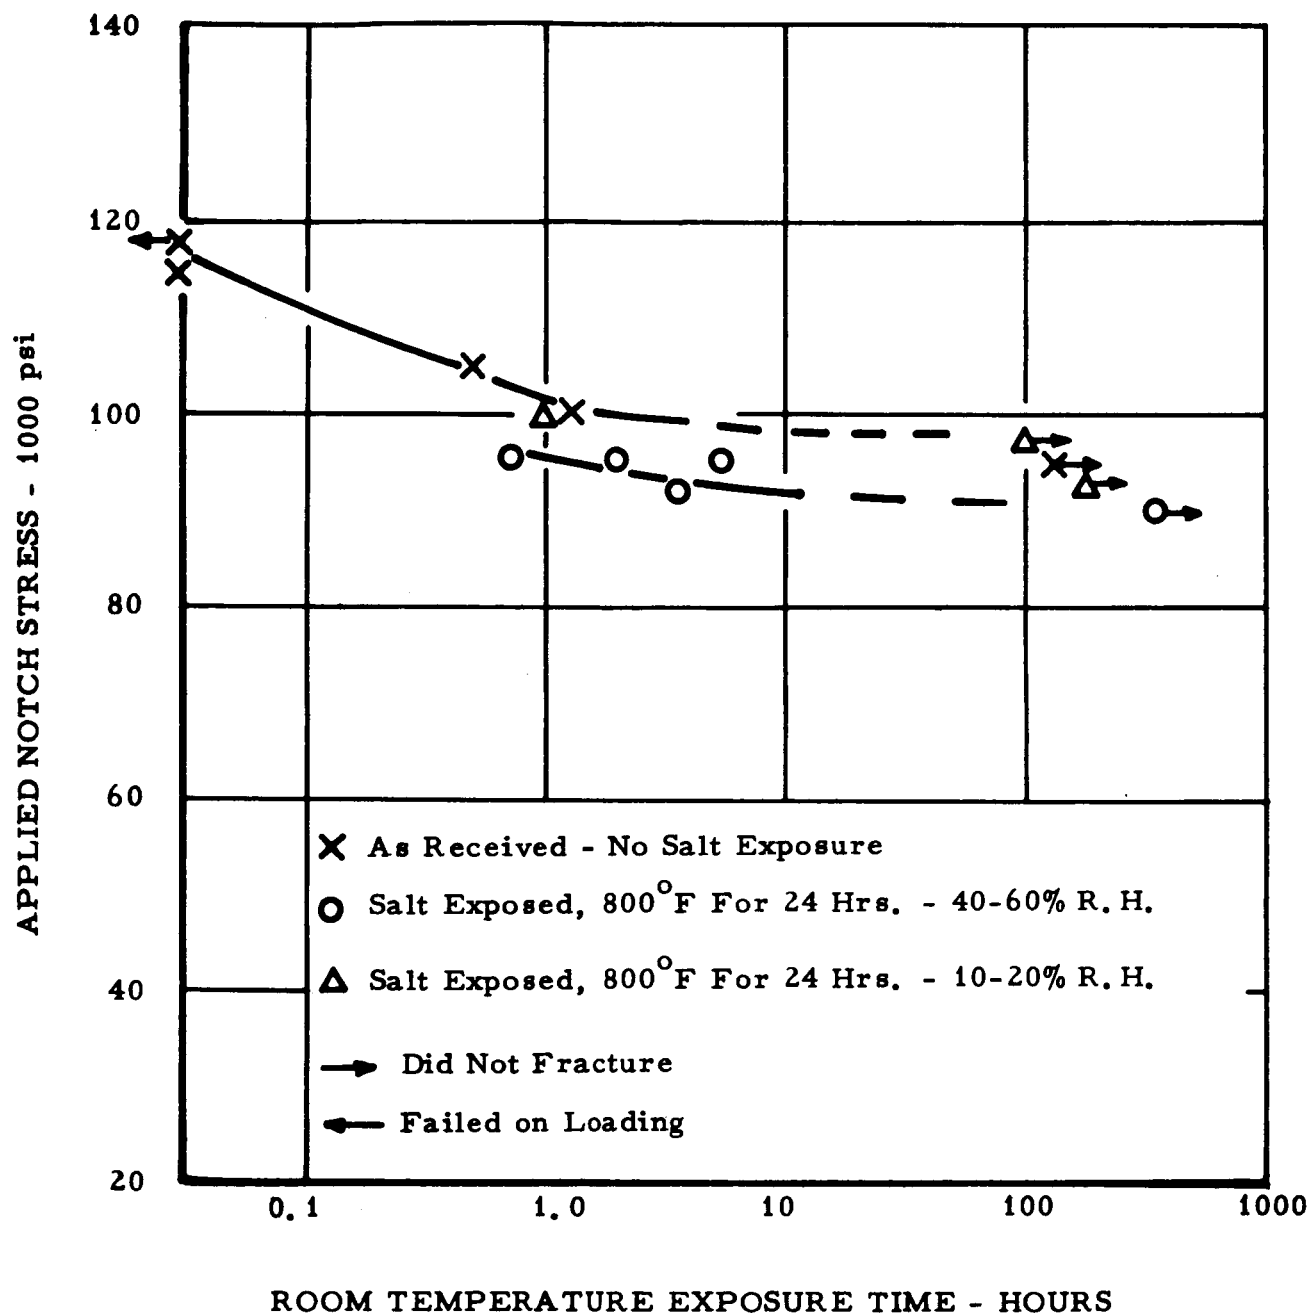
**Fig. 11 THE EFFECT OF AMBIENT HUMIDITY DURING HOT SALT EXPOSURE ON SUBSEQUENT ROOM TEMPERATURE DELAYED FRACTURE OF Ti-8Al-1Mo-1V.**

The high temperature exposure dates for these two series were selected so that room temperature humidity was 40 to 60 percent for one series, and 10 to 20 percent for the other. As shown in Fig. 11, delayed failure occurred at stress levels between 92 and 95,000 psi for the higher humidity exposure while for the lower humidity, failures did not occur below 100,000 psi. Indeed the specimens exposed at the lower humidity appeared to be no more embrittled than the control specimens. This need for some reasonably high humidity to cause hot salt cracking is consistent with the earlier Kirchner and Ripling finding (7).

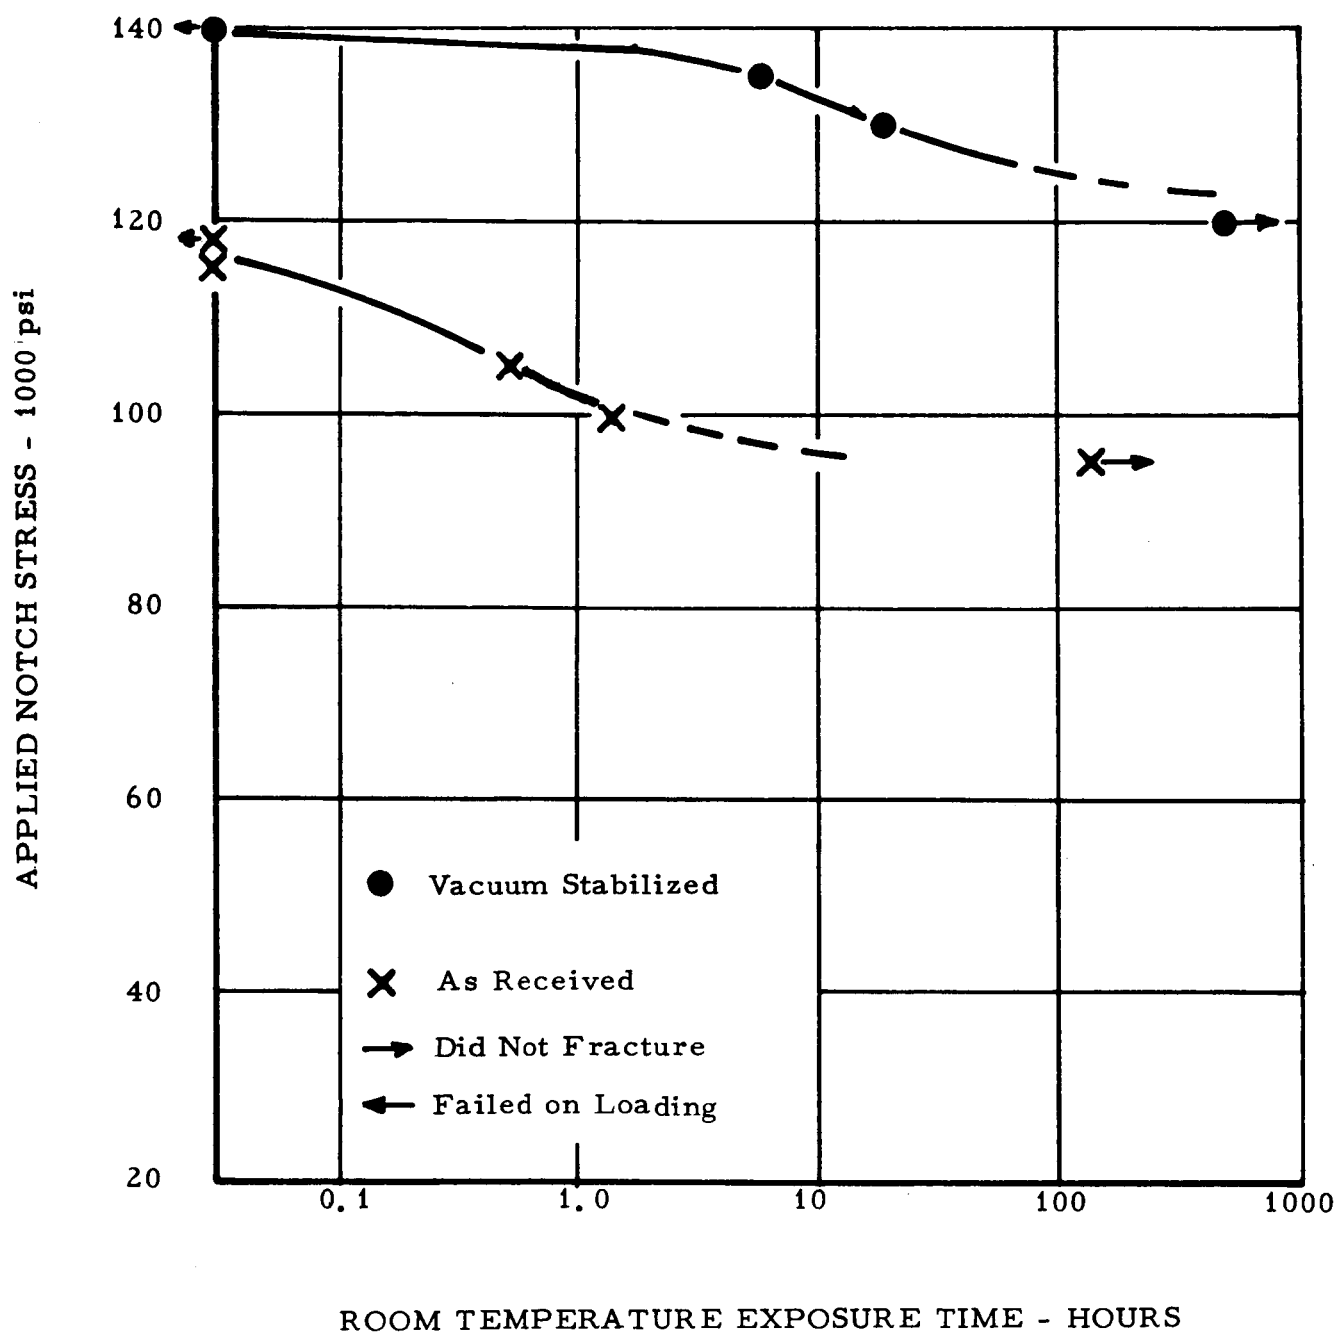
Fig. 12 THE EFFECT OF VACUUM ANNEALING ON ROOM TEMPERATURE DELAYED FRACTURE OF Ti-8Al-1Mo-1V.

delayed failure characteristics of the metal, it would be necessary to stabilize the specimens by means of a vacuum anneal prior to the salt exposure. As shown in Fig. 12, the stabilizing anneal ( $1300-1325^{\circ}\text{F}$  at  $5 \times 10^{-5}$  mm Hg for 24 hours) did so significantly improve the metal's resistance to delayed fracture that this treatment was used on all subsequent tests.

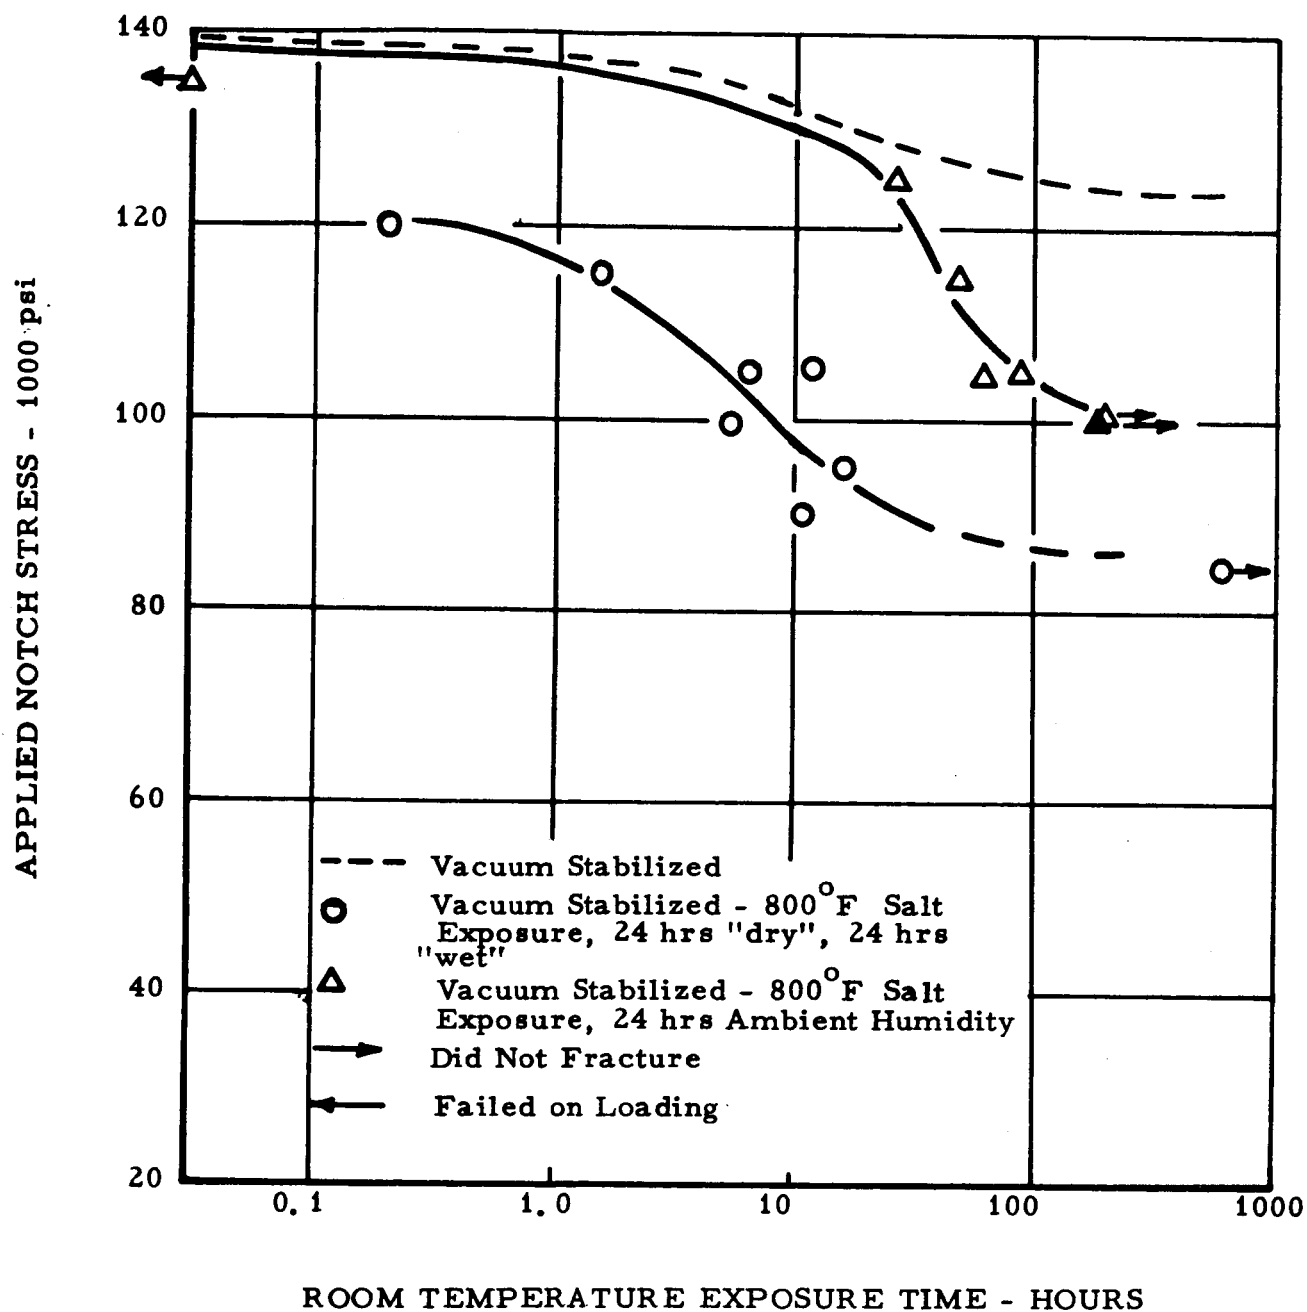
Fig. 13 THE EFFECT OF WATER VAPOR DURING HOT SALT EXPOSURE ON SUBSEQUENT ROOM TEMPERATURE DELAYED FRACTURE OF Ti-8Al-1Mo-1V.

As was found with the mill annealed specimens, the higher humidity caused a much more severe embrittlement, Fig. 13.

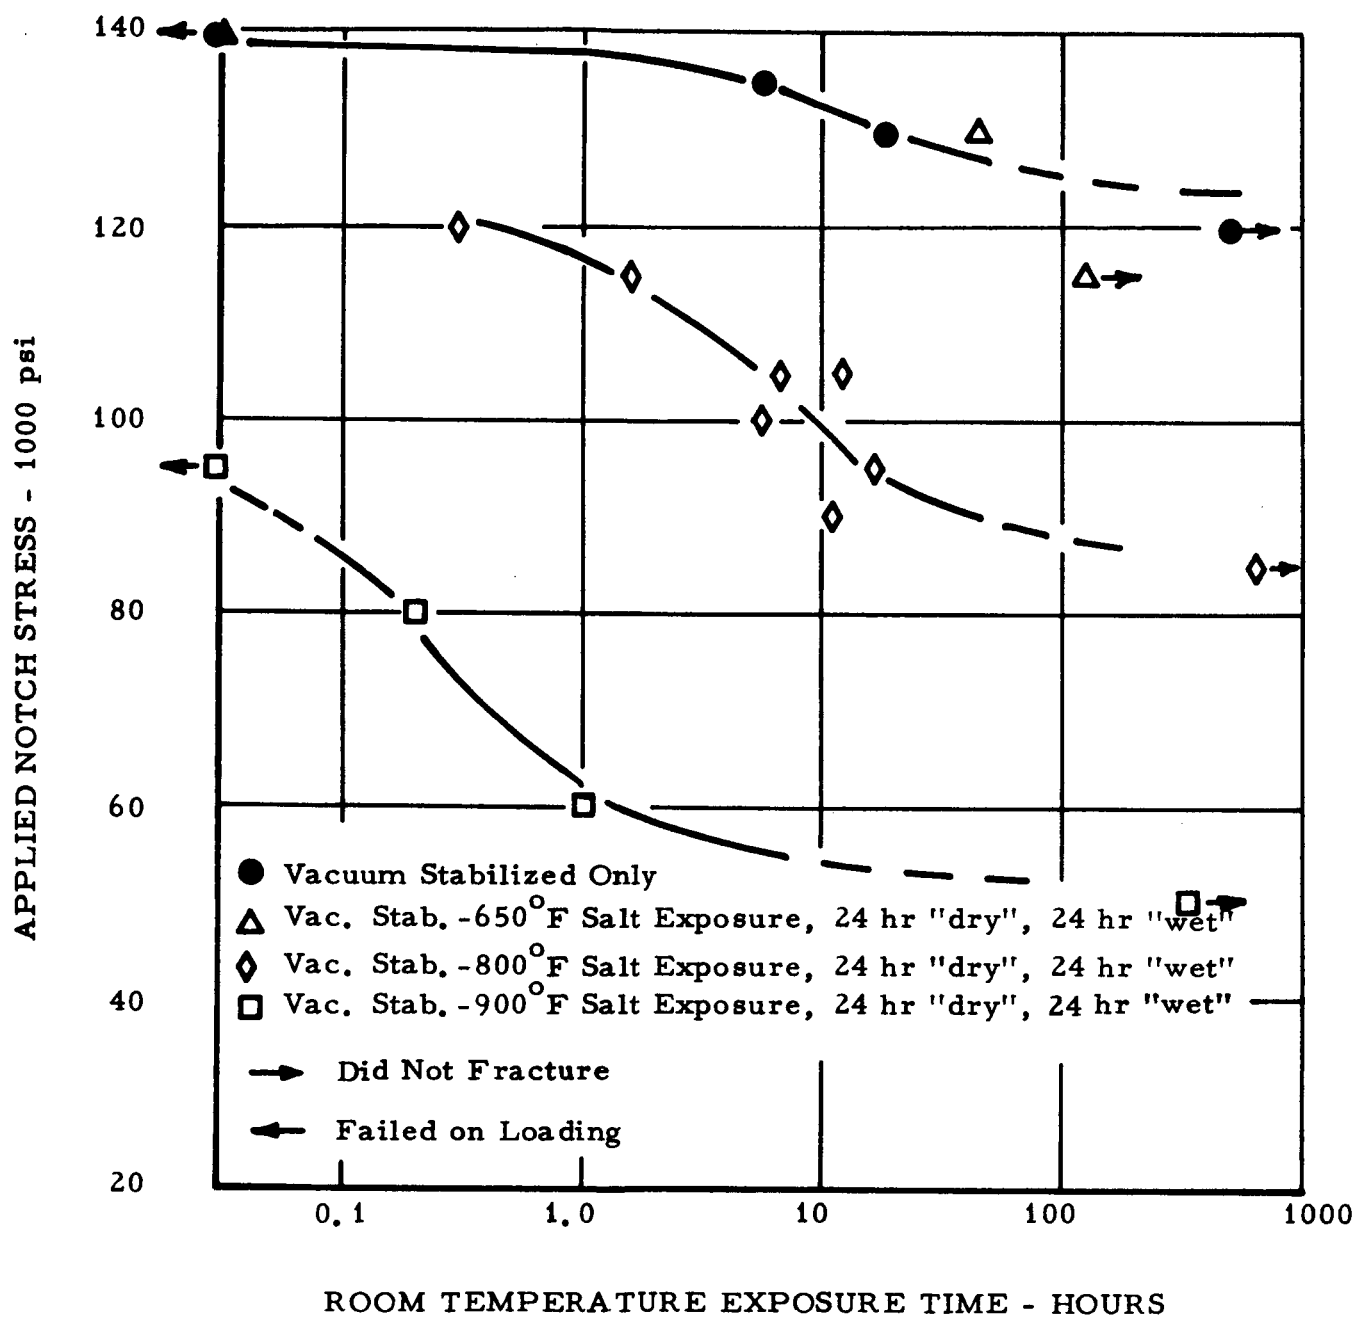
Fig. 14 THE EFFECT OF SALT EXPOSURE TEMPERATURES ON THE SUBSEQUENT ROOM TEMPERATURE DELAYED FRACTURE OF Ti-8Al-1Mo-1V.

Since the dry plus wet exposure causes such a pronounced embrittlement, this treatment was used to investigate the effect of exposure temperature. Specimens were treated by steps 1 to 5 above, except in 4a, temperatures between 650 and 900<sup>o</sup>F were used. As shown in Fig. 14, the higher the exposure temperature, the more severe the embrittlement.

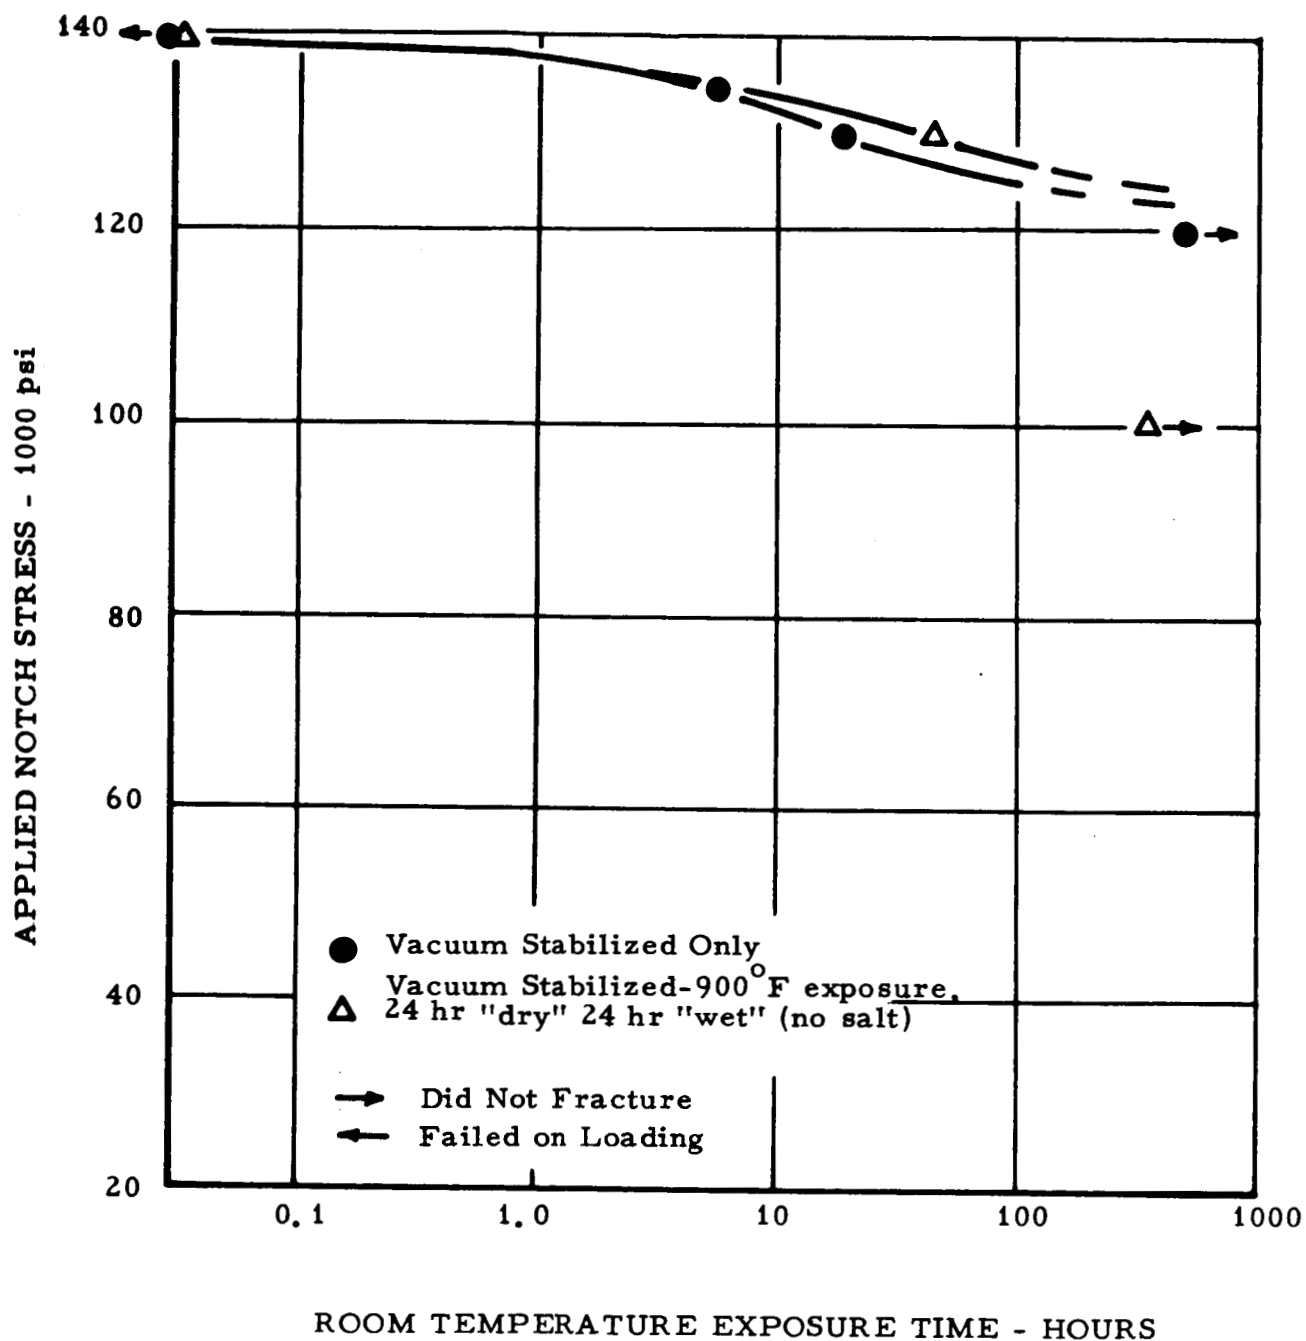
Fig. 15 THE EFFECT OF WATER VAPOR ALONE ON THE SUBSEQUENT ROOM TEMPERATURE DELAYED FRACTURE OF Ti-8Al-1Mo-1V.

To be certain that the embrittlement required salt and was not due simply to hydrogen pick-up from the steam, another series was conducted in which all the above steps were used except no salt was applied in step 3; the exposure temperature was 900<sup>o</sup>F. The subsequent room temperature stress-time curve for this material was identical with the specimens subjected to vacuum stabilization only, Fig. 15.
